**NASA TM X-73661**

**PLUGGING OF COOLING HOLES IN  
FILM-COOLED TURBINE VANES**

**by Daniel L. Deadmore and Carl E. Lowell  
Lewis Research Center  
Cleveland, Ohio 44135  
April 1977**

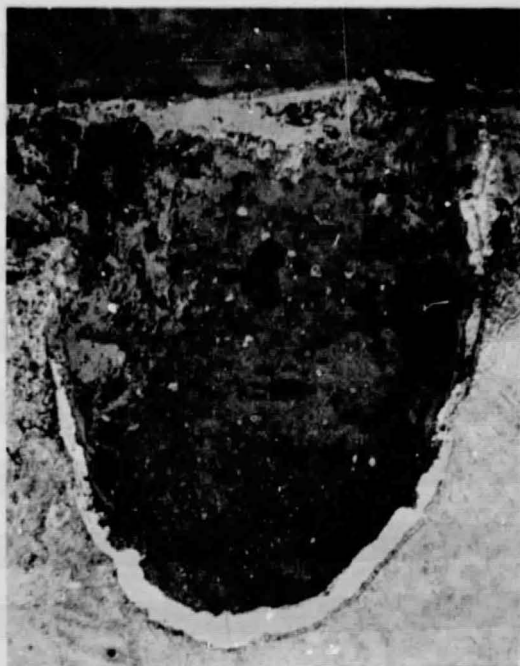
Figure 8 shows the microstructures of several deposits in and near a leading-edge hole. Parts a and b give a direct comparison between the deposit on a vane from the engine test with the burner rig produced deposit. Both deposits are porous and extensive, completely filling the cooling hole. Both deposits have similar major constituents (see table II) and both deposits have major amounts of  $\text{Fe}_2\text{O}_3$  and  $(\text{Ca, Mg})_4\text{Fe}_5(\text{PO}_4)_6$  although in the burner rig deposit the Mg level is zero in the phosphate phase. These data combined with the appearance of the vane as well as  $\Delta W$  and  $\Delta T$  data strongly suggest that the burner rig tests have closely simulated the conditions in the engine on an accelerated basis.

One interesting feature which is shown by these microstructures is the severe deposit cracking and spalling shown on all samples. This spalling is primarily due to thermal expansion mismatch between deposit and vane. This might be thought to be helpful; however, it appears that while the outer surface deposit may spall off, the deposits in the holes remain locked in place (see especially fig. 8(c)). Thus, while the addition of thermal cycling would substantially alter the measured  $\Delta W$ , it might have little effect on the plugging of cooling holes and hence  $\Delta T$ .

A. ENGINE TEST #2 DIESEL 100X  
1000 HOURS

B. MACH 0.3 TEST 2Fe, 1/2 Ca, 1 P 100X  
14.2 HOURS

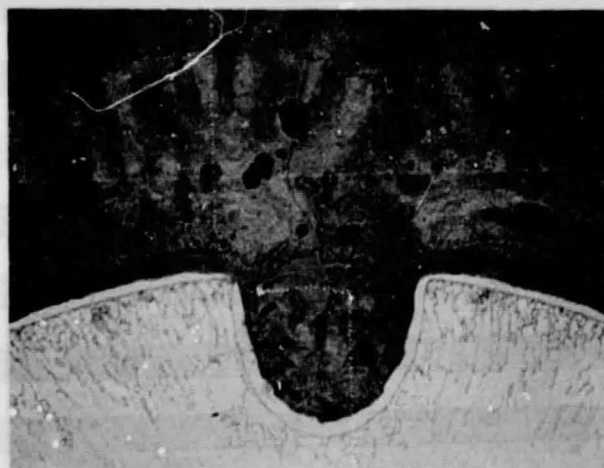
The rest of figure 8 serves to show that such deposits can form from a variety of dopant compositions. Increasing the phosphorus level yields a deposit which is quite glassy (fig. 8(c)), while increasing calcium levels increases granularity (fig. 8(d)). The Mg-Fe-P deposit (fig. 8(d)) is similar to the deposit resulting from doping with Ca-Fe-P. Finally, figure 8(f) shows that similar deposits can occur with only Fe and Ca.

C. MACH 0.3 TEST 2Fe, 1/2 Ca, 2P 50X  
6.4 HOURS

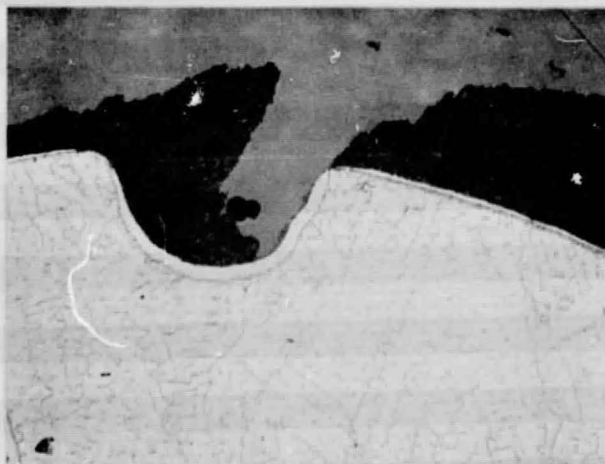
D. MACH 0.3 TEST 2Fe, 2Ca, 1P 50X  
13.8 HOURS

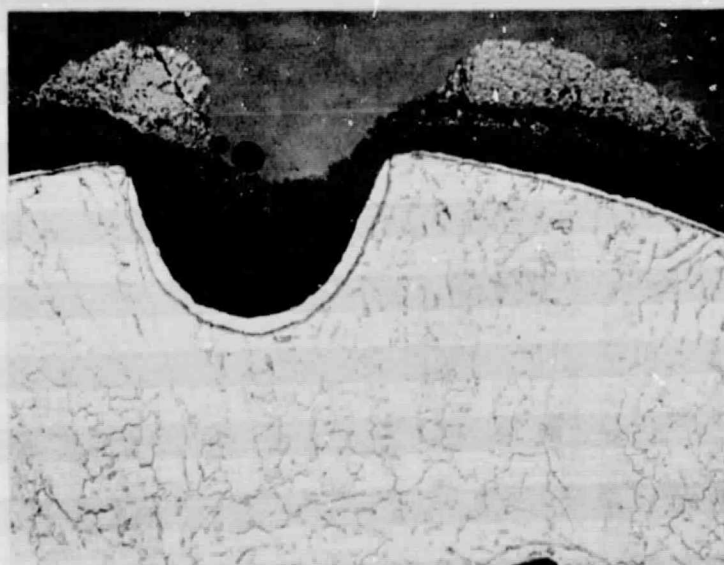
F. MACH 0.3 TEST  $2\text{Fe}, 1/2\text{Ca}$  50X  
10.0 HOURS
